model 5874PB

Fountain Valve

INSTALLATION INSTRUCTIONS FOR 5874PBF OR 5874SS W/ PBA6

INSTALLATION INSTRUCTIONS FOR 5874PB OR 5874SS W/ PBA7

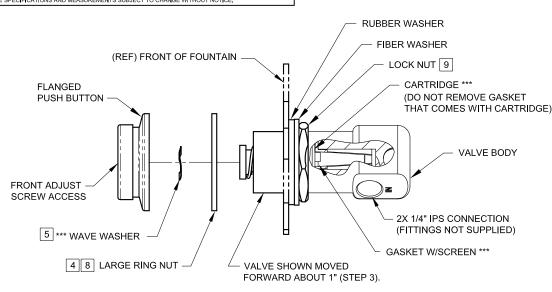
ASSEMBLED 5874PBF (FLUSH MOUNT APPLICATION)

*** MODEL VRK5874 - VALVE REPAIR KIT (INCLUDES THESE ITEMS)
USED ON ALL 5874SS SERIES VALVES

- 1) FOLLOW INSTRUCTIONS CAREFULLY ON 0&M MANUAL (PAGE 2 OF 6) WHEN REMOVING OLD VALVE. NOTE: SEE PARTS BREAKDOWN (PAGE 4 OF 6) FOR ADDITIONAL NOTES.
- VERIFY THAT LOCK NUT, FIBER, AND RUBBER WASHERS ARE POSITIONED SLIGHTLY PAST MIDWAY OF THREADS ON NEW VALVE BODY.

- 3) INSERT VALVE INTO FOUNTAIN FROM INSIDE AND PUSH FORWARD ABOUT 1".
- 4 THREAD LARGE RING NUT ONTO VALVE BODY, APPROXIMATELY 1" INTO VALVE.
- 5 PLACE WAVE WASHER INSIDE OF FLANGED PUSH BUTTON ASSEMBLY (MUST BE IN PLACE).

- 6 APPLY ONE (1) DOT OF LOCTITE 222MS, ON THE FEMALE THREADS OF BUTTON ASSEMBLY LEAVING THE FIRST AND LAST THREADS FREE. (FIGURE 1). CAUTION: EXCESS LOCTITE CAN CAUSE THREADS TO LOCK VERY TIGHTLY, MAKING REPAIRS DIFFICULT.

- **7) THREAD FLANGED PUSH BUTTON ASSEMBLY ON VALVE UNTIL WAVE WASHER MAKES SLIGHT CONTACT WITH STEM OF CARTRIDGE. CAUTION: DO NOT HAND-TIGHTEN.
- 8 UNTHREAD RING NUT FORWARD UNTIL IT STOPS FLUSH WITH PUSH BUTTON ASSEMBLY.

- 9 PUSH VALVE BACK TOWARD THE INSIDE OF FOUNTAIN AND TIGHTEN LOCKNUT (SEE ILLUSTRATION ABOVE).
- 10) TIGHTEN PUSH BUTTON ASSEMBLY USING UNIVERSAL SPANNER WRENCH PROVIDED.

- ** OVERTIGHTENING WILL PRE-ACTUATE VALVE AND CAUSE WEEPAGE, WHILE NOT ENOUGH CONTACT BETWEEN WAVE WASHER AND STEM CAN CAUSE A LOW FLOW CONDITION.

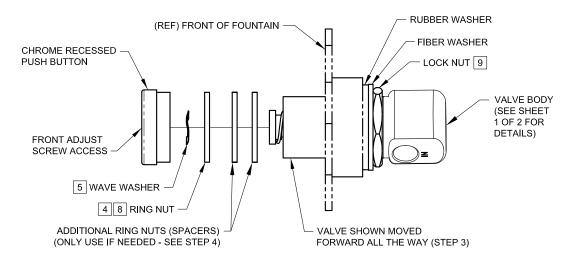
ASSEMBLED 5874PB (RECESSED MOUNT APPLICATION)

- 1) FOLLOW INSTRUCTIONS CAREFULLY ON 0&M MANUAL (PAGE 2 OF 6) WHEN REMOVING OLD VALVE. NOTE: SEE PARTS BREAKDOWN (PAGE 4 OF 6) FOR ADDITIONAL NOTES.
- VERIFY THAT LOCK NUT, FIBER, AND RUBBER WASHERS ARE POSITIONED TOWARD BOTTOM END OF THREADS ON NEW VALVE BODY.
- 3) INSERT VALVE INTO FOUNTAIN FROM INSIDE, AND PUSH ALL THE WAY FORWARD (SEE ILLUSTRATION ABOVE).
- [4] THREAD RING NUT ONTO VALVE BODY, AS FAR IN AS POSSIBLE, TOWARD FRONT OF FOUNTAIN.

NOTE: IF REPLACING A 5871 OR 5872 SERIES VALVE, YOU MAY HAVE TO PLACE ADDITIONAL

RING NUTS (TO BE USED AS SPACERS AND SUPPLIED W/5874PB) IN FRONT OF THE RING NUT

(SEE ILLUSTRATION ABOVE), TO ALLOW NEW LONGER VALVE TO FIT IN A TIGHT LOCATION.
- 5 PLACE WAVE WASHER INSIDE OF PUSH BUTTON ASSEMBLY (MUST BE IN PLACE).

- 6 APPLY ONE (1) DOT OF LOCTITE 222MS, ON THE FEMALE THREADS OF BUTTON ASSEMBLY LEAVING THE FIRST AND LAST THREADS FREE. (FIGURE 1). CAUTION: EXCESS LOCTITE CAN CAUSE THREADS TO LOCK VERY TIGHTLY, MAKING REPAIRS DIFFICULT.

- **7) THREAD PUSH BUTTON ASSEMBLY ON VALVE UNTIL WAVE WASHER MAKES SLIGHT CONTACT WITH STEM OF CARTRIDGE, CAUTION: DO NOT HAND-TIGHTEN.
- 8 UNTHREAD RING NUT FORWARD UNTIL IT STOPS FLUSH WITH PUSH BUTTON ASSEMBLY.

- 9 PUSH VALVE BACK TOWARD THE INSIDE OF FOUNTAIN AND TIGHTEN LOCKNUT (SEE ILLUSTRATION ABOVE).
- 10) TIGHTEN PUSH BUTTON ASSEMBLY USING UNIVERSAL SPANNER WRENCH PROVIDED.

- ** OVERTIGHTENING WILL PRE-ACTUATE VALVE AND CAUSE WEEPAGE, WHILE NOT ENOUGH CONTACT BETWEEN WAVE WASHER AND STEM CAN CAUSE A LOW FLOW CONDITION.
