Instruction Sheet

Tub Support Top Seal Replacement

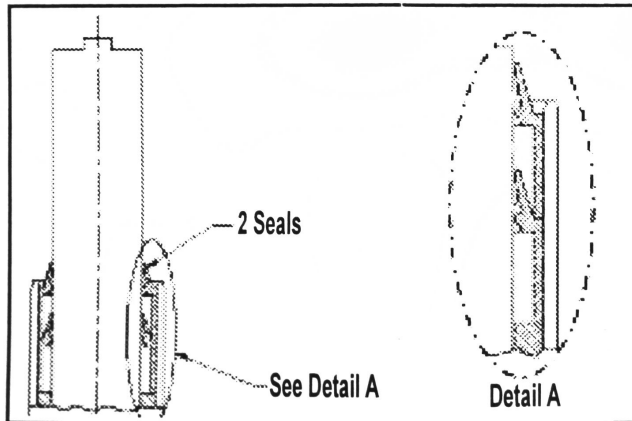
Figure 1

1. When replacing the tub support top seals, the washer may contain (1) one or (2) two seals. If the washer contains (2) two seals (See *Figure 1*), be sure to remove both seals, only (1) one of the new redesigned seals will be required to replace the (2) seals removed (See *Figure 2*). If the washer already contains (1) one top seal, replace as shown in *Figure 2*.
