Haws®

model **VRK5874**

Drinking Fountain/Electric Water Cooler Parts & Access.

Model VRK5874 is a valve repair kit for Model 5874. Includes wave washer, cartridge regulator and 60 mesh strainer.

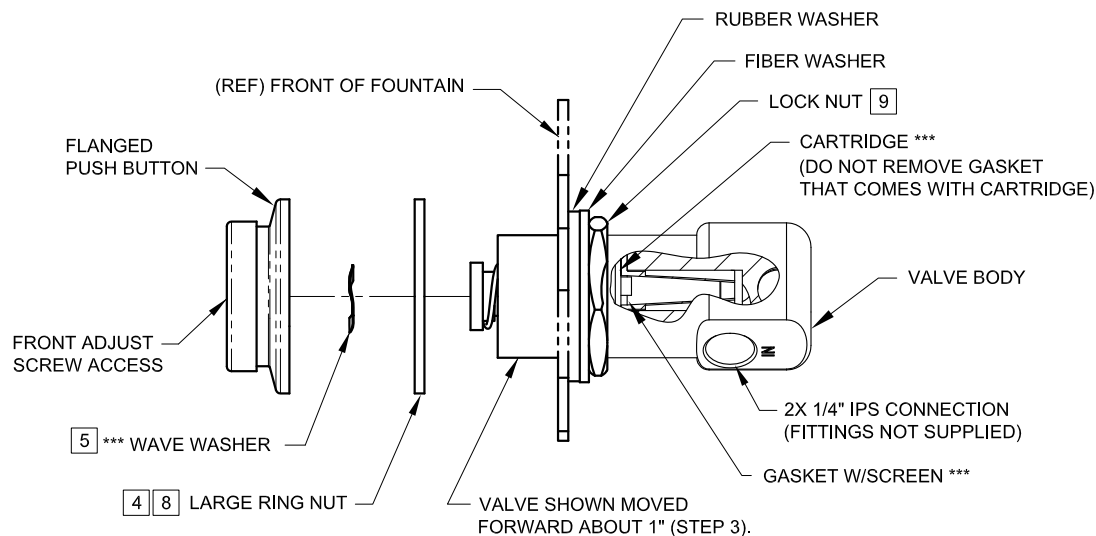
ASSEMBLED 5874PBF
(FLUSH MOUNT APPLICATION)

*** MODEL VRK5874 - VALVE REPAIR KIT (INCLUDES THESE ITEMS)
USED ON ALL 5874SS SERIES VALVES

INSTALLATION INSTRUCTIONS FOR 5874PBF OR 5874SS W/ PBA6

- 1) FOLLOW INSTRUCTIONS CAREFULLY ON O&M MANUAL (PAGE 2 OF 6) WHEN REMOVING OLD VALVE. **NOTE: SEE PARTS BREAKDOWN (PAGE 4 OF 6) FOR ADDITIONAL NOTES.**

- 2) VERIFY THAT LOCK NUT, FIBER, AND RUBBER WASHERS ARE POSITIONED SLIGHTLY PAST MIDWAY OF THREADS ON NEW VALVE BODY.
- 3) INSERT VALVE INTO FOUNTAIN FROM INSIDE AND PUSH FORWARD ABOUT 1".

- 4] THREAD LARGE RING NUT ONTO VALVE BODY, APPROXIMATELY 1" INTO VALVE.
- 5] PLACE WAVE WASHER INSIDE OF FLANGED PUSH BUTTON ASSEMBLY (**MUST BE IN PLACE**).

- 6] APPLY ONE (1) DOT OF LOCTITE 222MS, ON THE FEMALE THREADS OF BUTTON ASSEMBLY LEAVING THE FIRST AND LAST THREADS FREE. (FIGURE 1). **CAUTION: EXCESS LOCTITE CAN CAUSE THREADS TO LOCK VERY TIGHTLY, MAKING REPAIRS DIFFICULT.**

- **7) THREAD FLANGED PUSH BUTTON ASSEMBLY ON VALVE UNTIL WAVE WASHER MAKES SLIGHT CONTACT WITH STEM OF CARTRIDGE. **CAUTION: DO NOT HAND-TIGHTEN.**
- 8] UNTHREAD RING NUT FORWARD UNTIL IT STOPS FLUSH WITH PUSH BUTTON ASSEMBLY.

- 9] PUSH VALVE BACK TOWARD THE INSIDE OF FOUNTAIN AND TIGHTEN LOCKNUT (SEE ILLUSTRATION ABOVE).
- 10) TIGHTEN PUSH BUTTON ASSEMBLY USING UNIVERSAL SPANNER WRENCH PROVIDED.

** OVERTIGHTENING WILL PRE-ACTUATE VALVE AND CAUSE WEEPAGE, WHILE NOT ENOUGH CONTACT BETWEEN WAVE WASHER AND STEM CAN CAUSE A LOW FLOW CONDITION.

THIS VALVE IS PRESSURE COMPENSATING.
BE SURE TO REMOVE ANY EXISTING FLOW
CONTROL DEVICES. (MAY BE PRESENT IN
FITTING OR SPUD).

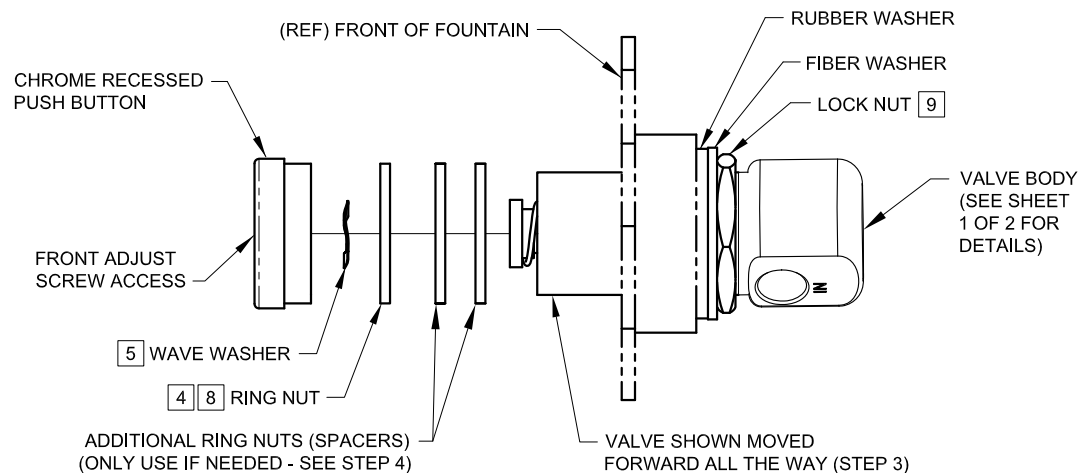
ASSEMBLED 5874PB
(RECESSED MOUNT APPLICATION)

INSTALLATION INSTRUCTIONS FOR 5874PB OR 5874SS W/ PBA7

- 1) FOLLOW INSTRUCTIONS CAREFULLY ON O&M MANUAL (PAGE 2 OF 6) WHEN REMOVING OLD VALVE. **NOTE: SEE PARTS BREAKDOWN (PAGE 4 OF 6) FOR ADDITIONAL NOTES.**

- 2) VERIFY THAT LOCK NUT, FIBER, AND RUBBER WASHERS ARE POSITIONED TOWARD BOTTOM END OF THREADS ON NEW VALVE BODY.
- 3) INSERT VALVE INTO FOUNTAIN FROM INSIDE, AND PUSH ALL THE WAY FORWARD (SEE ILLUSTRATION ABOVE).

- 4) THREAD RING NUT ONTO VALVE BODY, AS FAR IN AS POSSIBLE, TOWARD FRONT OF FOUNTAIN. **NOTE: IF REPLACING A 5871 OR 5872 SERIES VALVE, YOU MAY HAVE TO PLACE ADDITIONAL RING NUTS (TO BE USED AS SPACERS AND SUPPLIED W/5874PB) IN FRONT OF THE RING NUT (SEE ILLUSTRATION ABOVE), TO ALLOW NEW LONGER VALVE TO FIT IN A TIGHT LOCATION.**

- 5) PLACE WAVE WASHER INSIDE OF PUSH BUTTON ASSEMBLY (**MUST BE IN PLACE**).
- 6) APPLY ONE (1) DOT OF LOCTITE 222MS, ON THE FEMALE THREADS OF BUTTON ASSEMBLY LEAVING THE FIRST AND LAST THREADS FREE. (FIGURE 1). **CAUTION: EXCESS LOCTITE CAN CAUSE THREADS TO LOCK VERY TIGHTLY, MAKING REPAIRS DIFFICULT.**

- **7) THREAD PUSH BUTTON ASSEMBLY ON VALVE UNTIL WAVE WASHER MAKES SLIGHT CONTACT WITH STEM OF CARTRIDGE. **CAUTION: DO NOT HAND-TIGHTEN.**
- 8) UNTHREAD RING NUT FORWARD UNTIL IT STOPS FLUSH WITH PUSH BUTTON ASSEMBLY.

- 9) PUSH VALVE BACK TOWARD THE INSIDE OF FOUNTAIN AND TIGHTEN LOCKNUT (SEE ILLUSTRATION ABOVE).
- 10) TIGHTEN PUSH BUTTON ASSEMBLY USING UNIVERSAL SPANNER WRENCH PROVIDED.

** OVERTIGHTENING WILL PRE-ACTUATE VALVE AND CAUSE WEEPAGE, WHILE NOT ENOUGH CONTACT BETWEEN WAVE WASHER AND STEM CAN CAUSE A LOW FLOW CONDITION.

* 6 APPLY 1 DOT OF
LOCTITE 222MS
(WHERE SHOWN)

* THIS ALSO APPLIES
TO PBA7

THIS VALVE IS PRESSURE COMPENSATING.
BE SURE TO REMOVE ANY EXISTING FLOW
CONTROL DEVICES. (MAY BE PRESENT IN
FITTING OR SPUD).
