Instruction Sheet

Description: Roller Kit

Repair Part Number: LA-1008

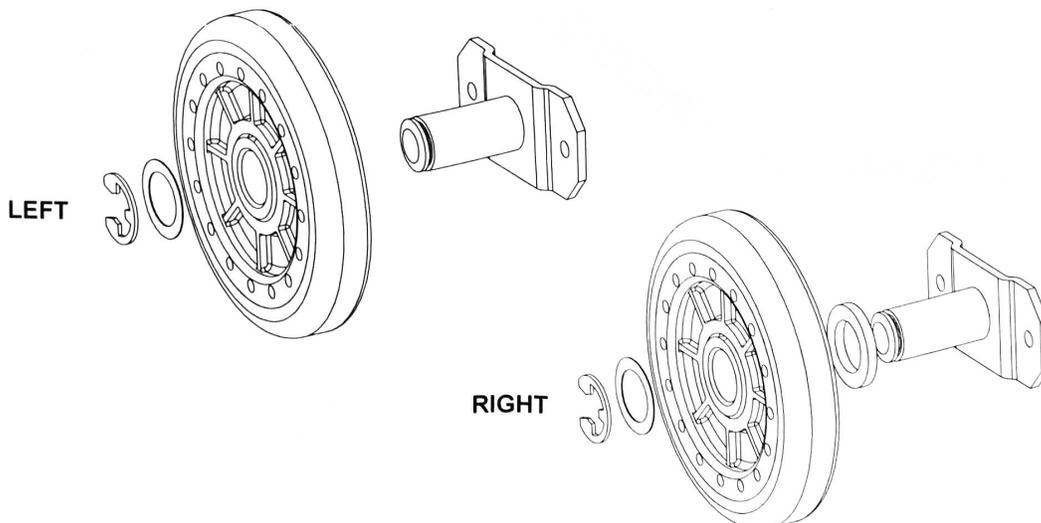
Procedure:

Install both cylinder rollers supplied in this kit at the same time.

The Spacer supplied in this kit (31001583) is to be used on the right rear Support Assembly only.

Note: Previously released kit contained two thinner washers. When stacked together they add up to the same thickness as the one provided in this kit.

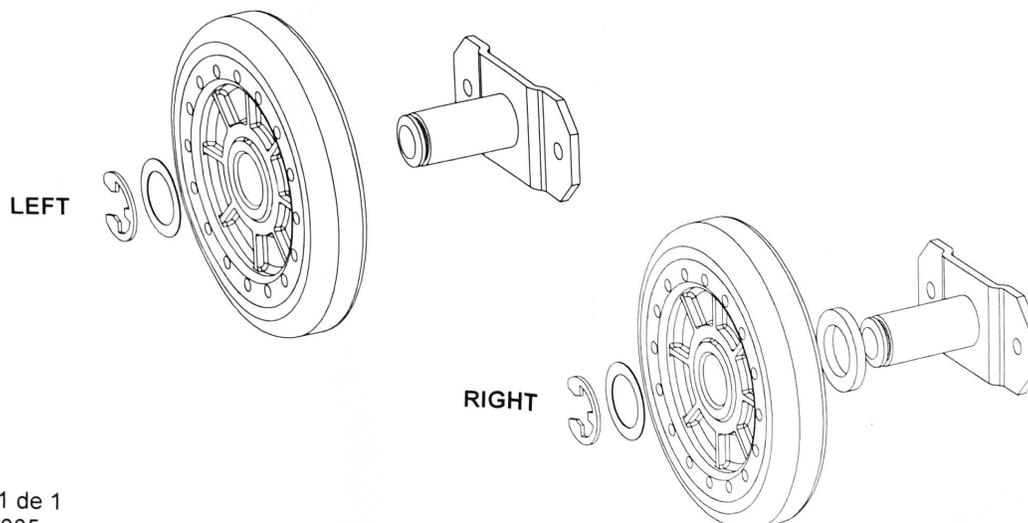
Étapes à suivre :

Installer en même temps les deux galets de cylindre fournis dans cette trousse.

La butée d'espacement fournie dans cette trousse (31001583) doit être utilisée sur le support arrière droit seulement.

Remarque : Les trousse précédentes contenaient des rondelles plus minces. Lorsqu'elles sont empilées ensemble, elles ont la même épaisseur que celle fournie dans cette trousse.
